# ADA Transition Plan

01.18.2022 FINAL

The Town of Apex is creating their first Americans with Disabilities Act (ADA) Transition Plan to ensure that town-owned facilities are compliant with the 2010 ADA Standards for Accessible Design and the International Building Code (IBC). The Transition Plan evaluates the existing conditions of each facility, and it identifies violations as well as improvements necessary to ensure accessibility and usability by persons with disabilities. The ADA of 1990 is a civil rights law that prohibits discrimination against people with disabilities. The ADA states that by designing and constructing facilities for public use that are not accessible to people with disabilities could constitute a discrimination. The ADA applies to all facilities, including those built before and after 1990, and local governments are required to perform a self-evaluation of their infrastructure and identify all barriers to accessibility. An ADA Transition Plan shall then be developed to address all accessibility related deficiencies. This Plan is a living document that will be utilized by the Town of Apex as a guide and can change, based on available resources and prioritie

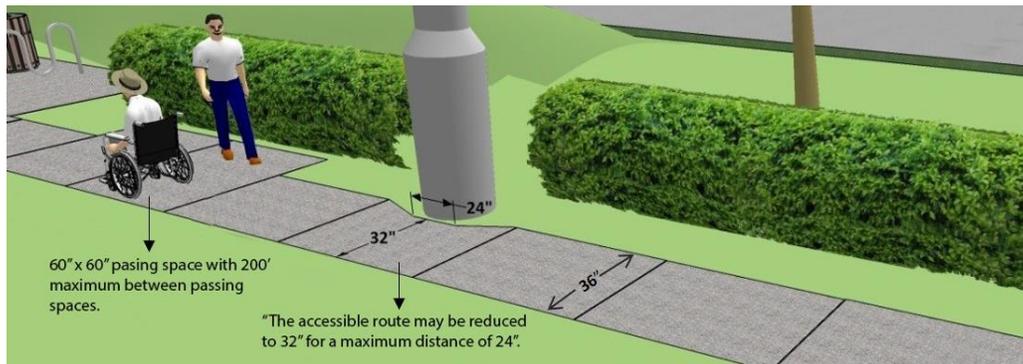
Figure 2.2 Accessible Route Standards Diagram

- Changes in level greater than 1/2” are not allowed or must be ramped (beveled at a 45-degree slope).
- Gaps in gratings must be no greater than 1/2” wide and openings must be aligned perpendicular to travel.

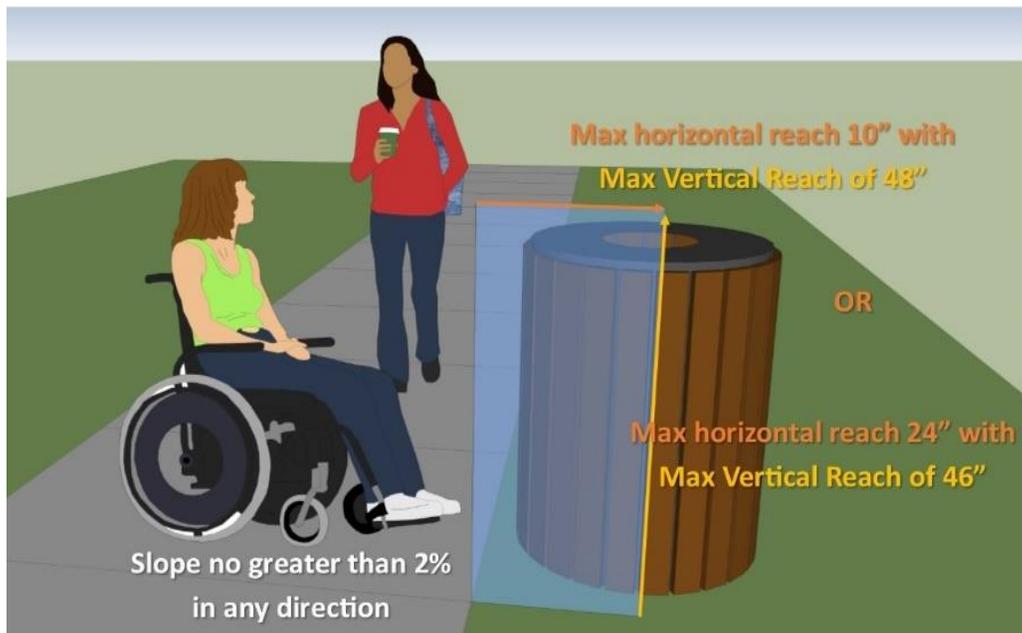
Figure 2.9 Accessible Garbage Can Located Adjacent to Paved Trail

It should be stressed that amenities that are located off the accessible path are considered inaccessible. For items to be accessible, they must be located on, adjacent to, or within reach of a firm, stable, and slip-resistant surface, as shown in Figure 2.9.

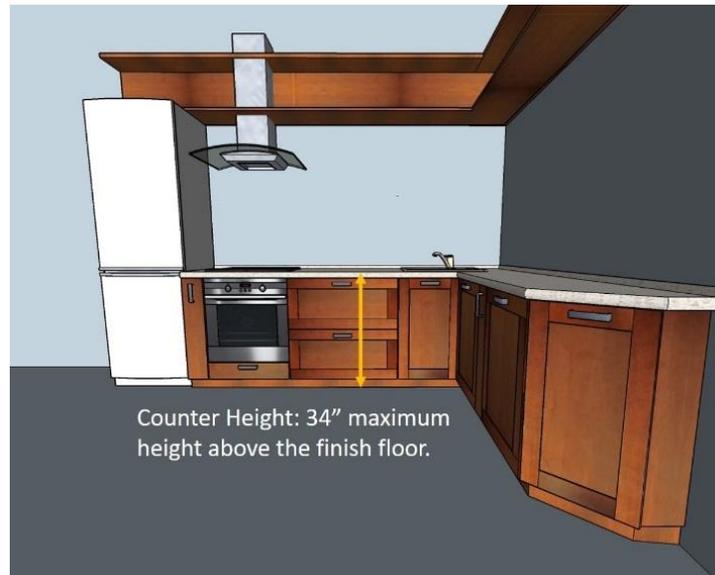
Figure 2.17 Accessible Dining and Work Surface

- Clear floor space complying with §305 positioned for a forward approach shall be provided.

- The tops of dining surfaces and work surfaces shall be 28” minimum and 34” maximum above the finish floor or ground.
- Accessible dining surfaces and work surfaces for children’s use shall comply with §902.4.
